Blood flow images from a normal renal scan:

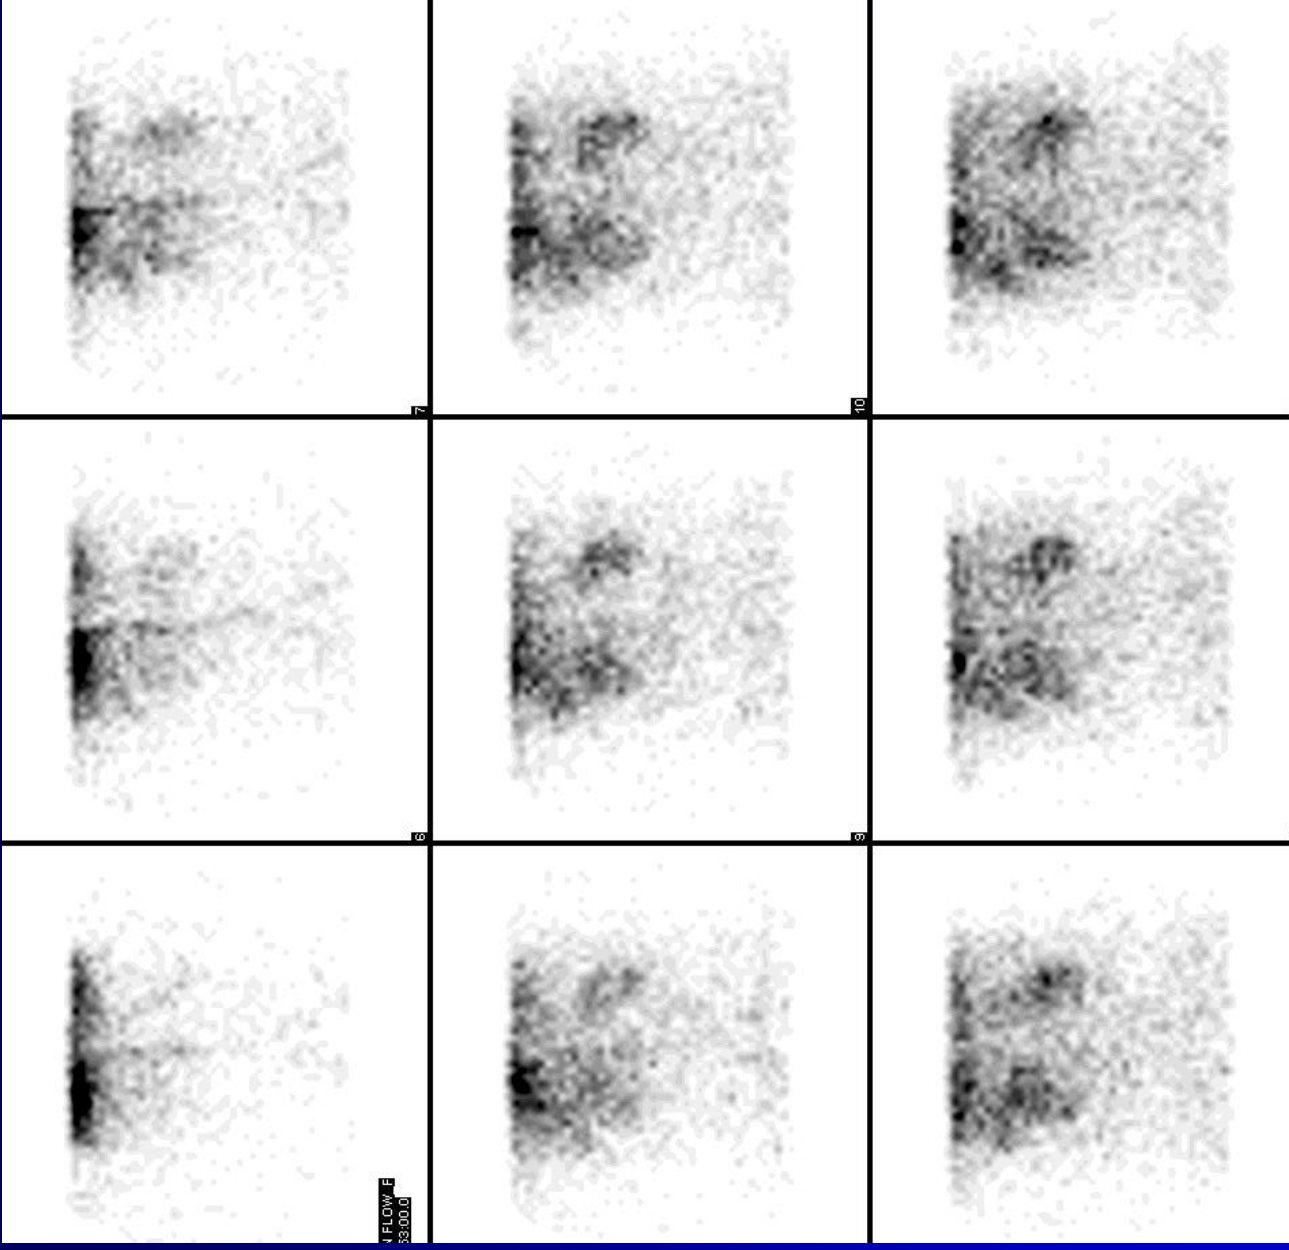
Dynamic flow images (1-2 min/frame) of the abdomen and pelvis are acquired in the posterior projection, after the IV administration 10 mCi of Tc99m MAG3, followed

by dynamic nephrogram images, acquired in the same projection (1 min/frame for 30 min.). Additional images may be acquired after the IV administration of lasix (diuresis renography) to evaluate for obstruction. Prompt and symmetric activity is seen in both kidneys.

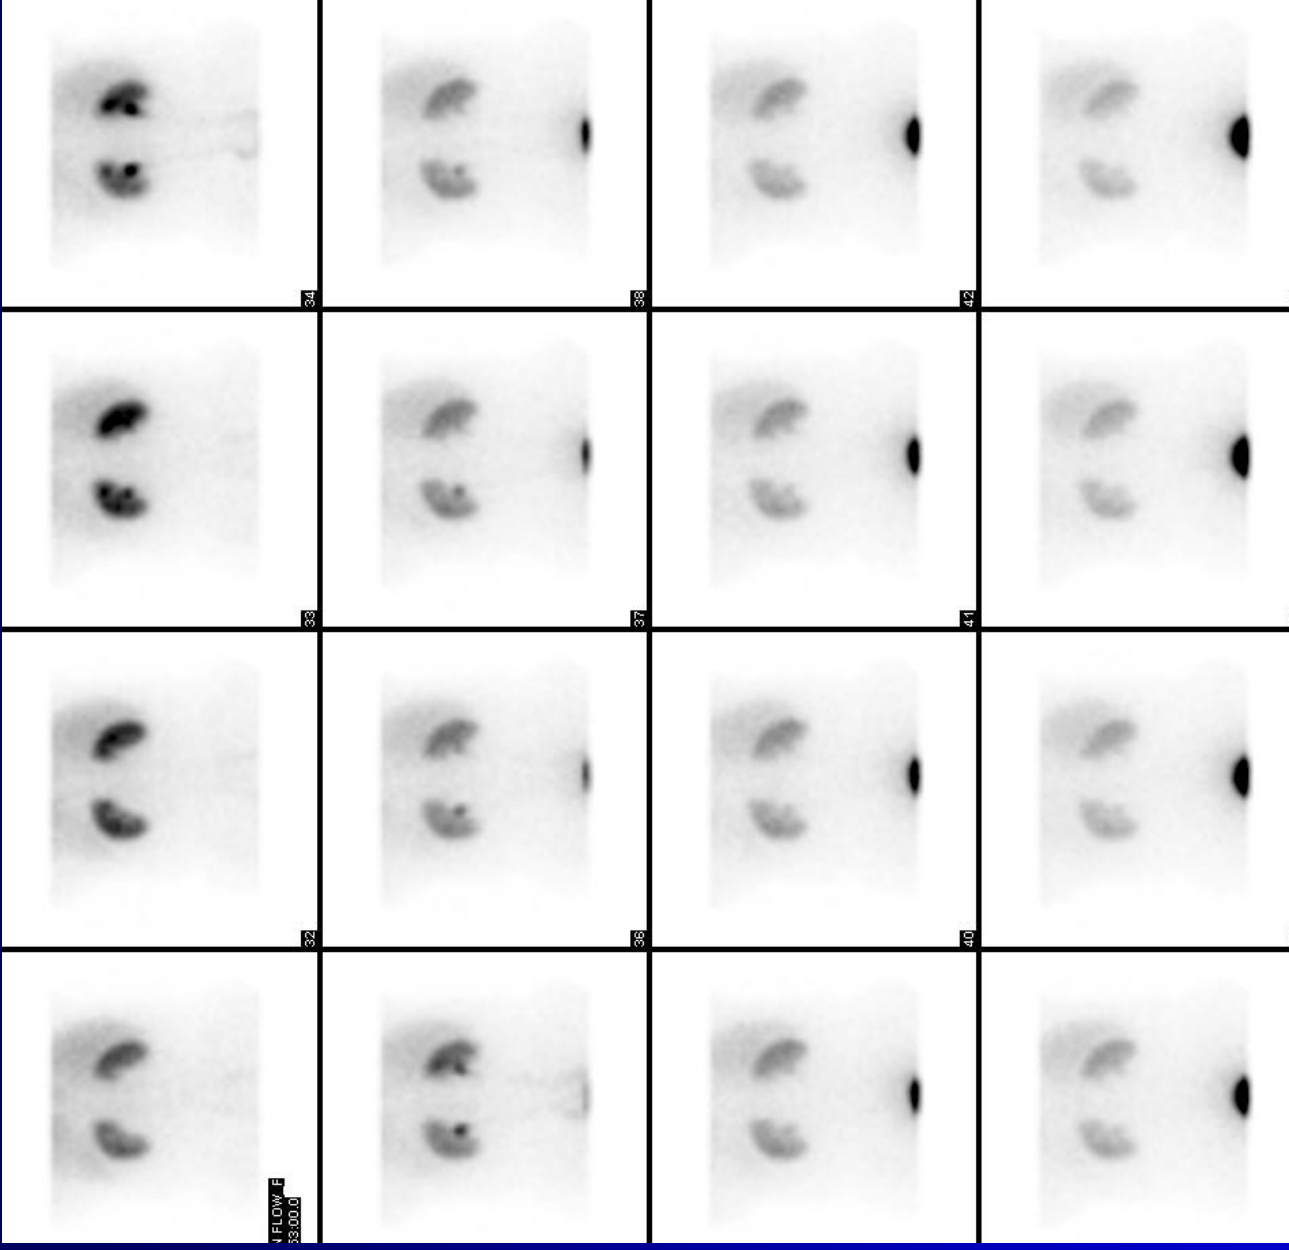
Nephrogram images from a normal renal scan: Good uptake and excretion of the tracer is seen bilaterally, from the kidneys, into the ureters and the urinary bladder.

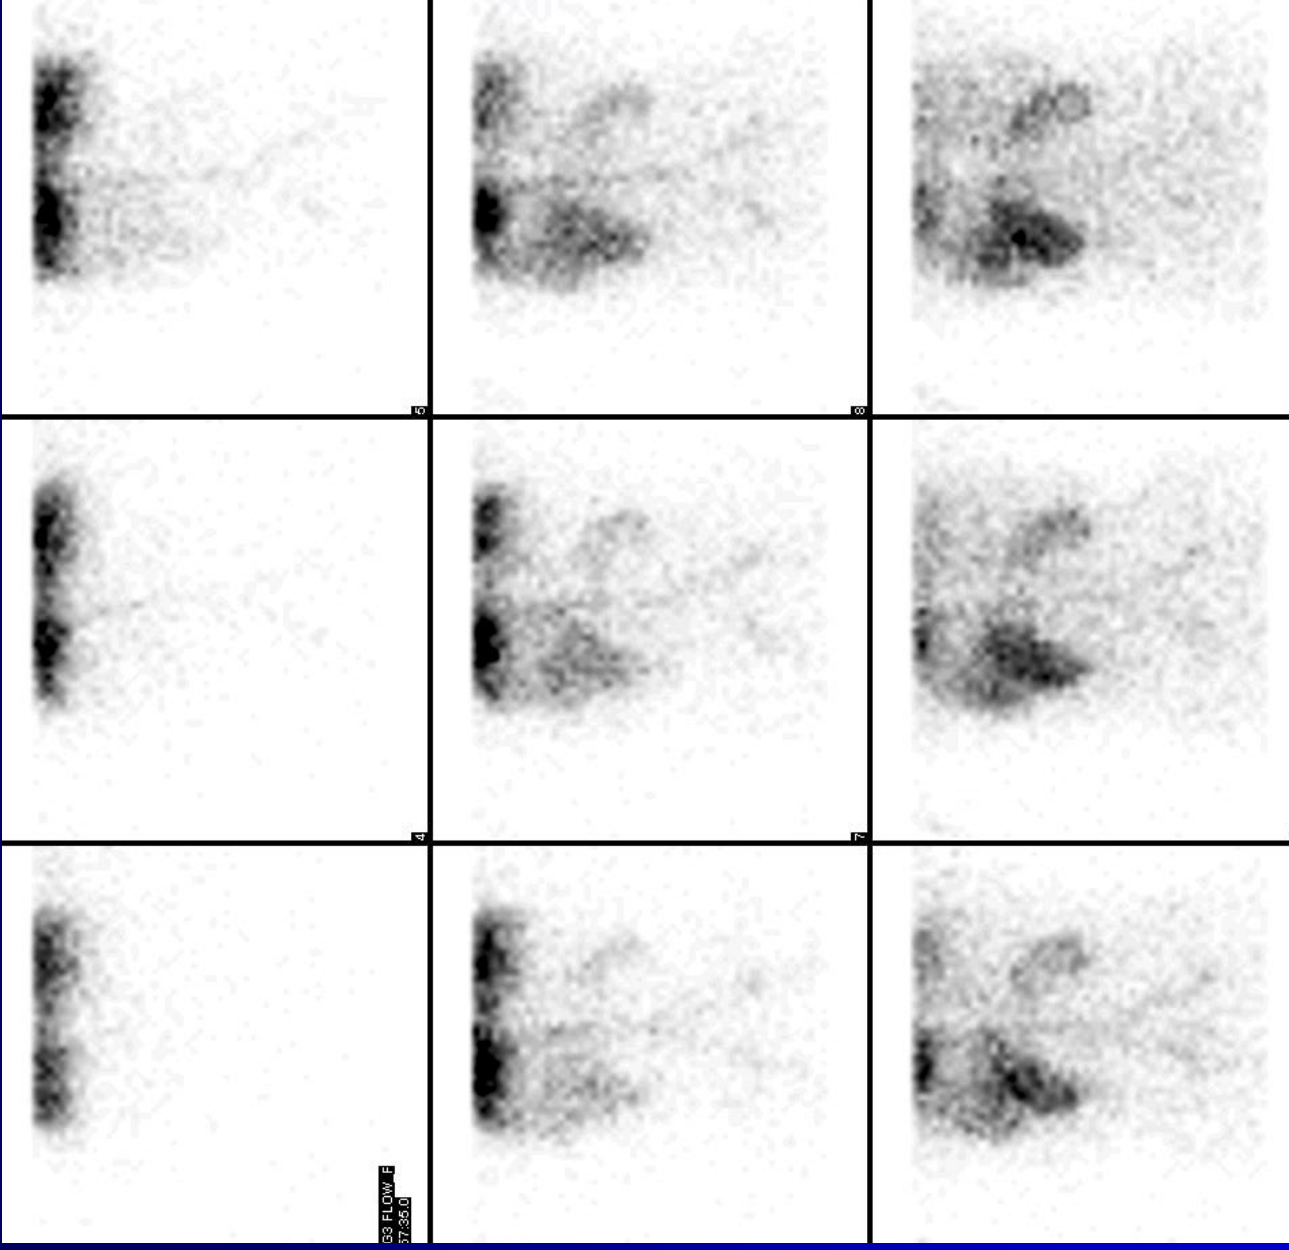
Blood flow images from a renal scan: delayed and diminished blood flow is seen in the right kidney.

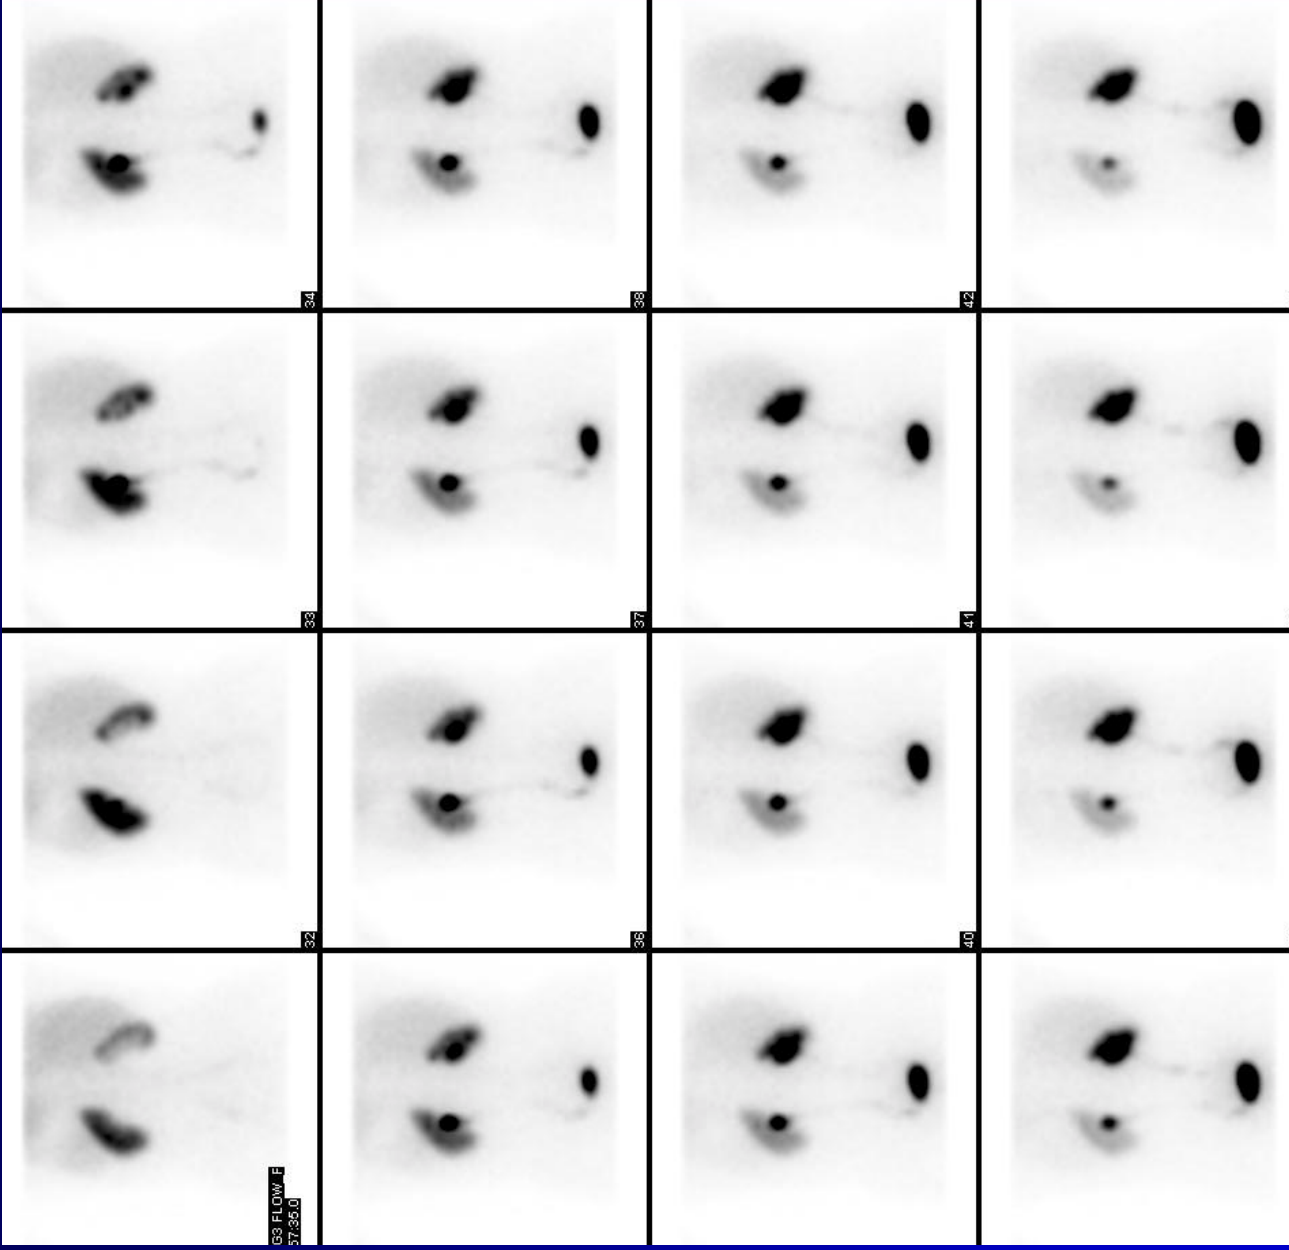
Nephrogram images from the renal scan: decreased uptake is seen in the right kidney, with a normal cortical transit and stasis of the tracer in the pelvis, suspicious for obstruction. Good uptake and excretion of the tracer is seen on the left.

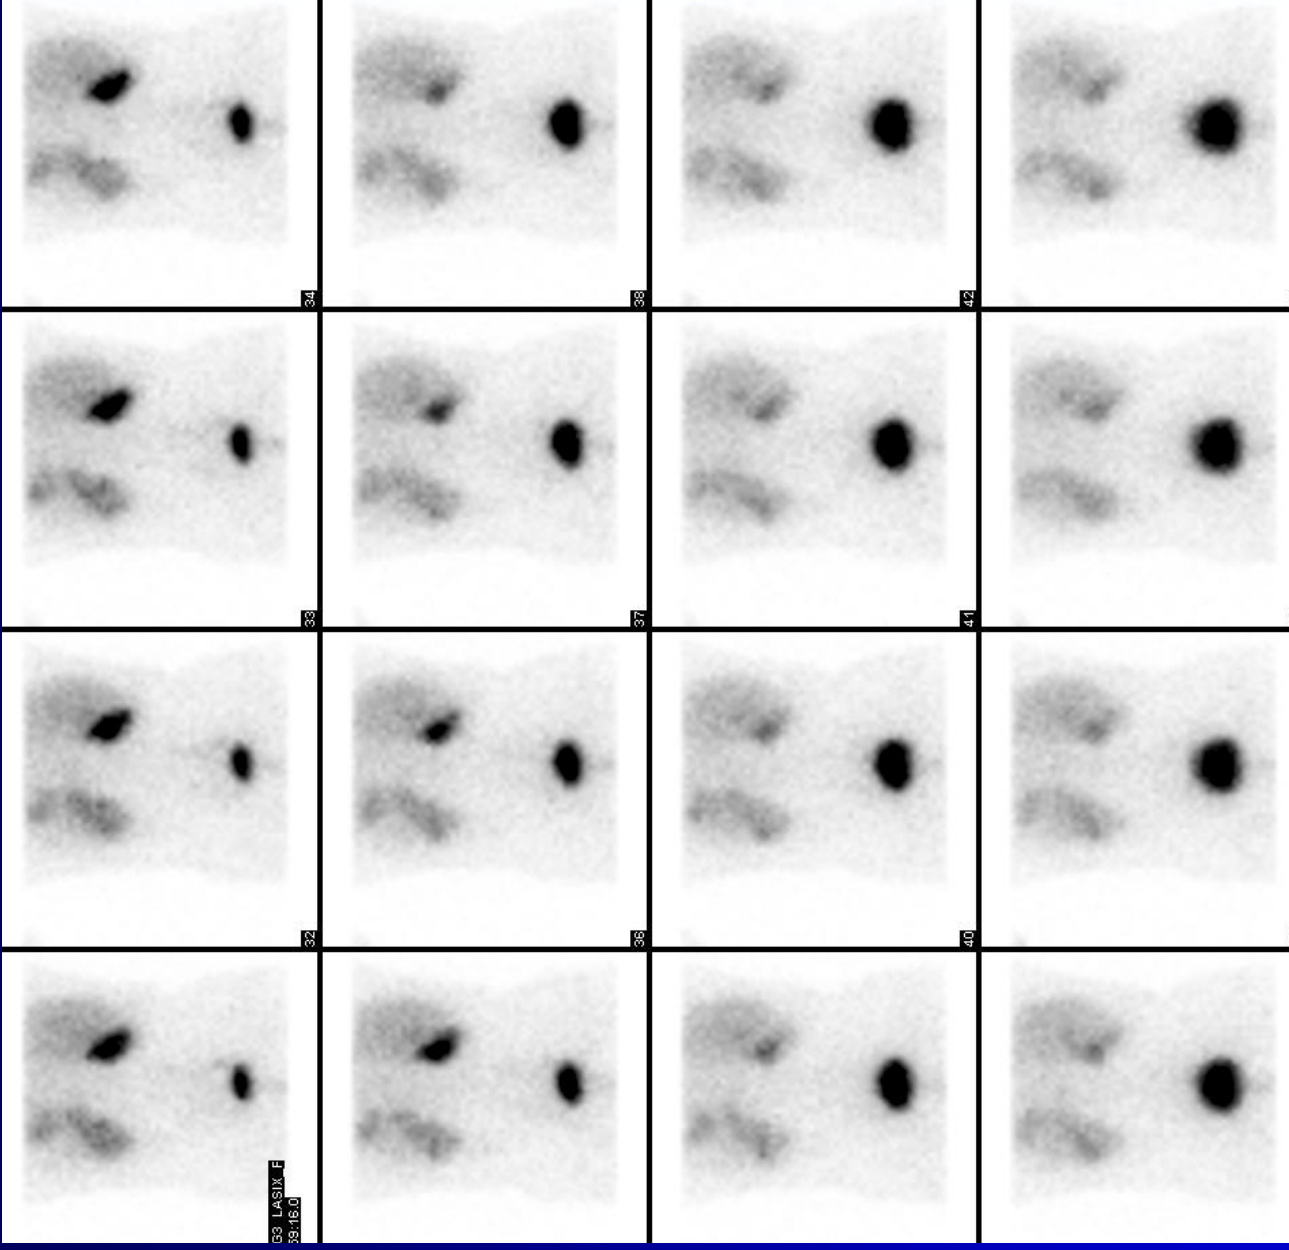
Post lasix images showing washout of activity from the pelvis of the right kidney, with a half time of emptying of < 10 min, ruling out obstruction. Findings are likely to be consistent with prior obstruction.

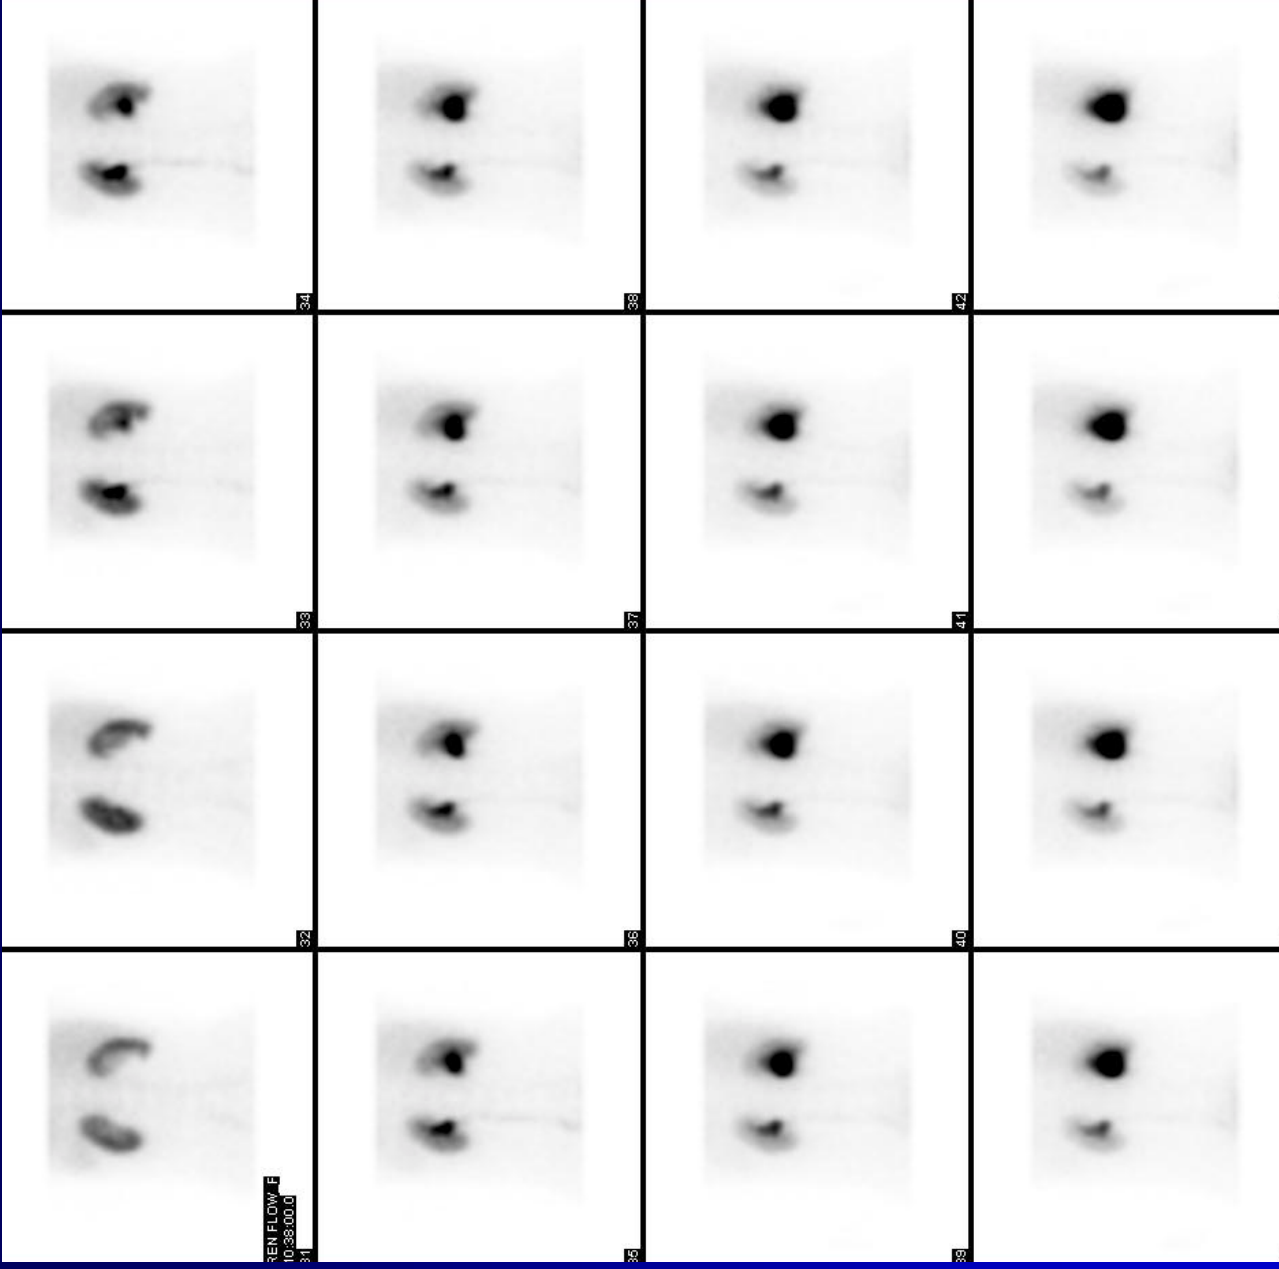
Nephrogram images from the renal scan: decreased uptake and normal cortical transit is seen on the right side. Stasis of activity is also seen in the right renal pelvis, right renal pelvis, suspicious for obstruction. Good uptake and excretion of the tracer is seen on the left.

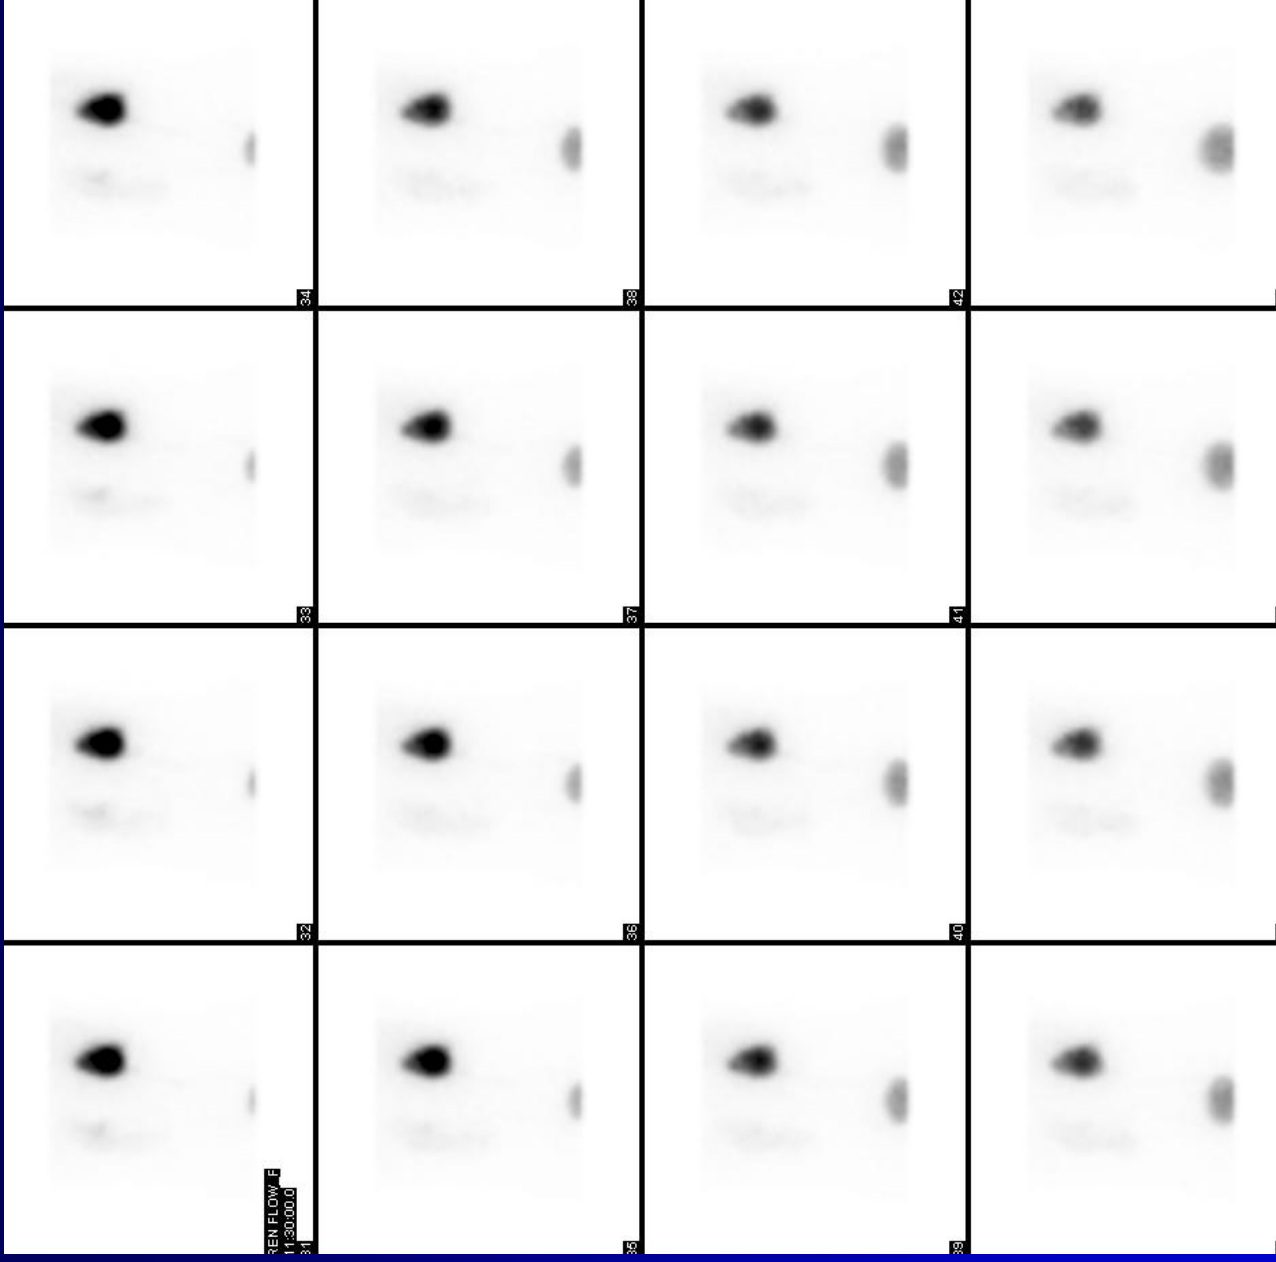
Post lasix images showing stasis of activity in the obstructed right kidney. The half time of emptying in response to lasix was >20 min, consistent with high grade UPJ obstruction.

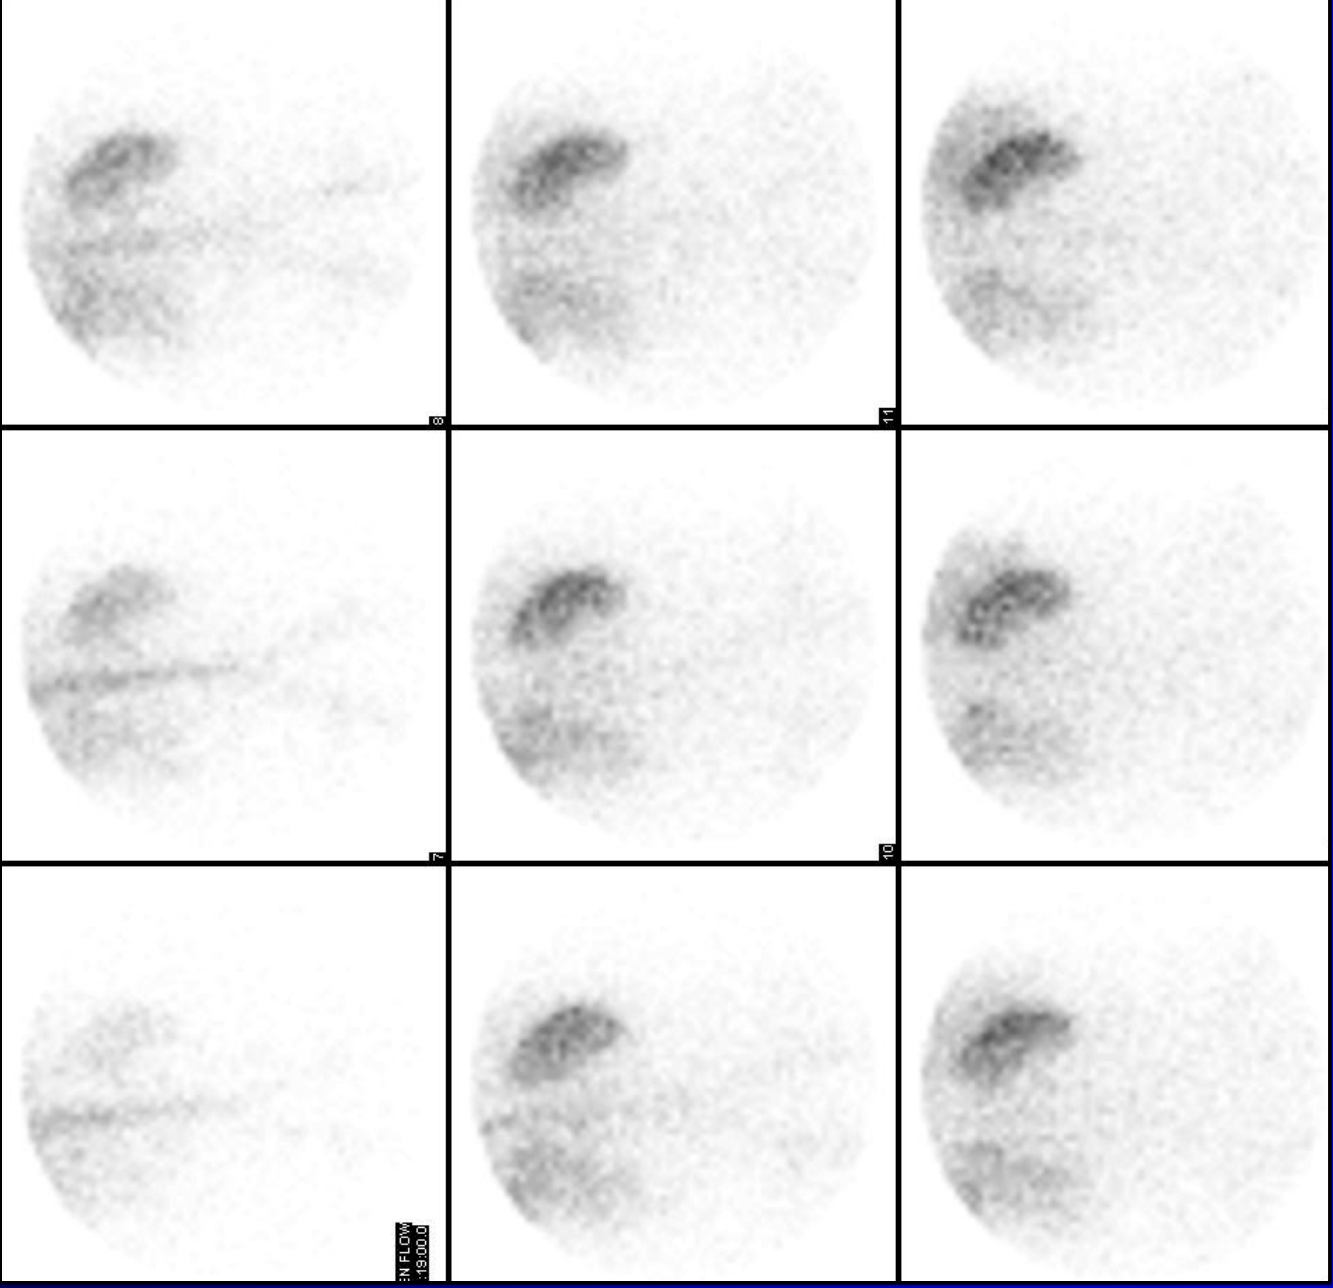
Blood flow images from a renal scan: delayed and diminished blood flow is seen in the left kidney.

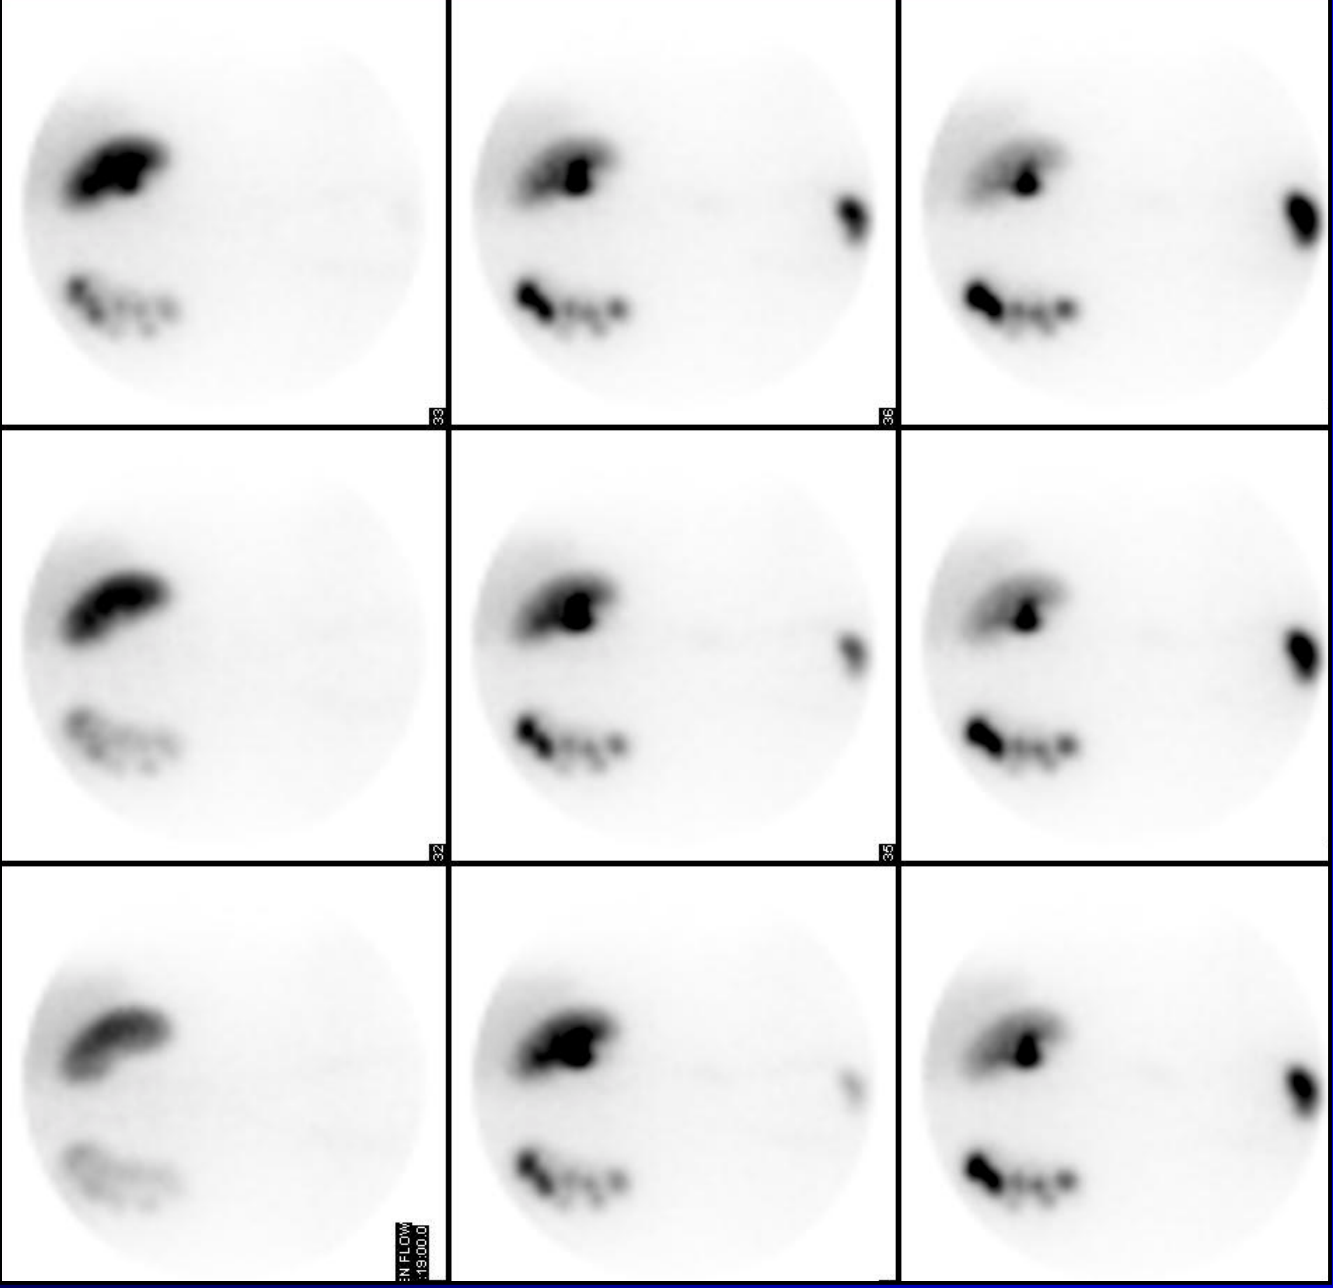
Nephrogram images from the renal scan: decreased and patchy uptake is seen in the enlarged left kidney, with minimal cortical transit. Good uptake and excretion of the tracer is seen on the right side.

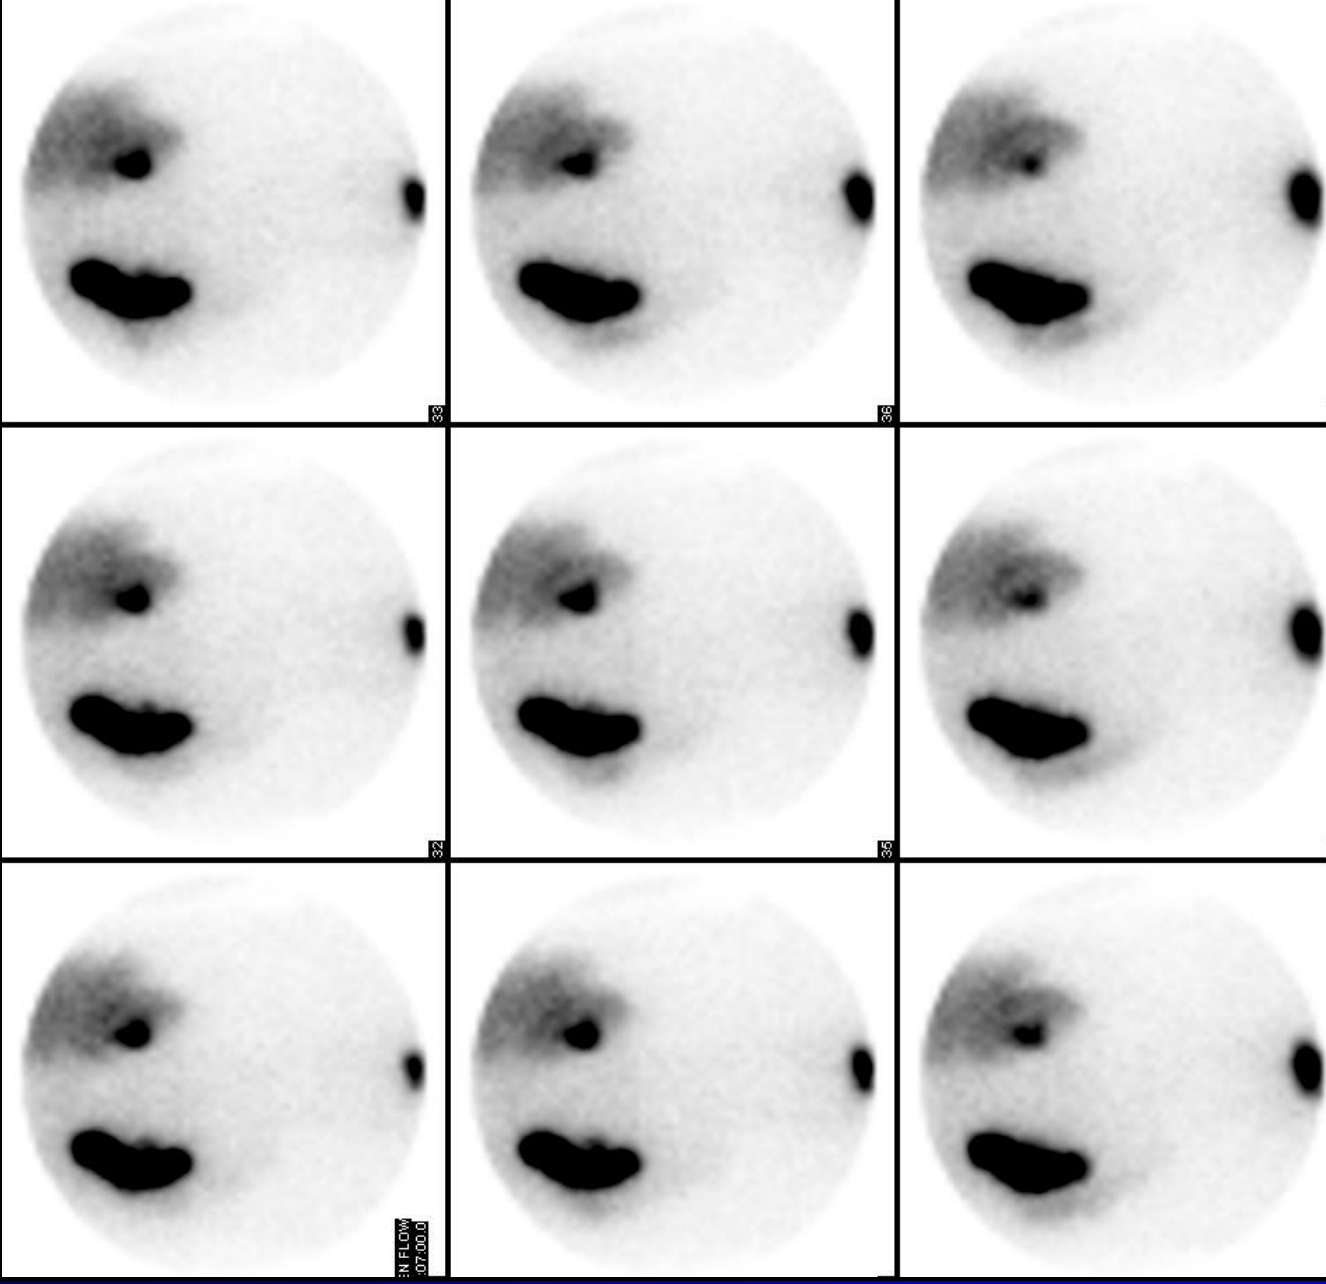
Post lasix images showing stasis of activity in the obstructed left kidney and leakage of urine from the thinned cortex, into the retroperitoneal space. No half time of emptying was achieved in response to lasix.

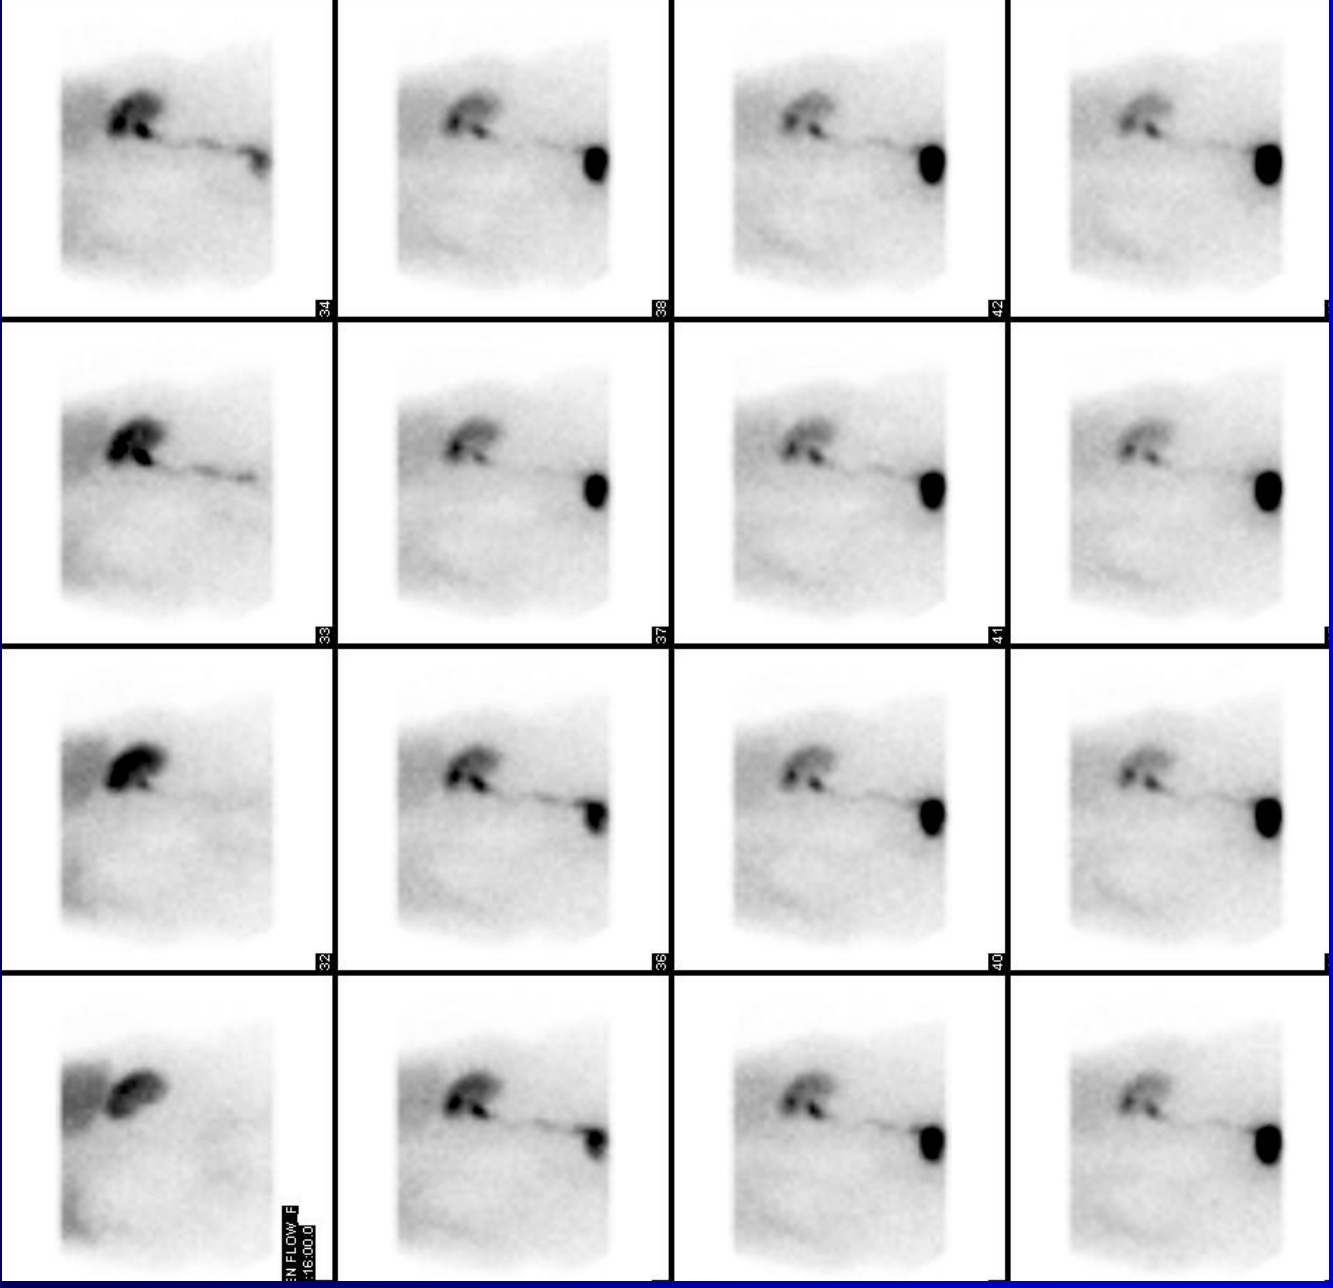
Nephrogram images from the renal scan : no activity is seen in the chronically obstructed left kidney. Normal function and no evidence of obstruction are seen in the right kidney.

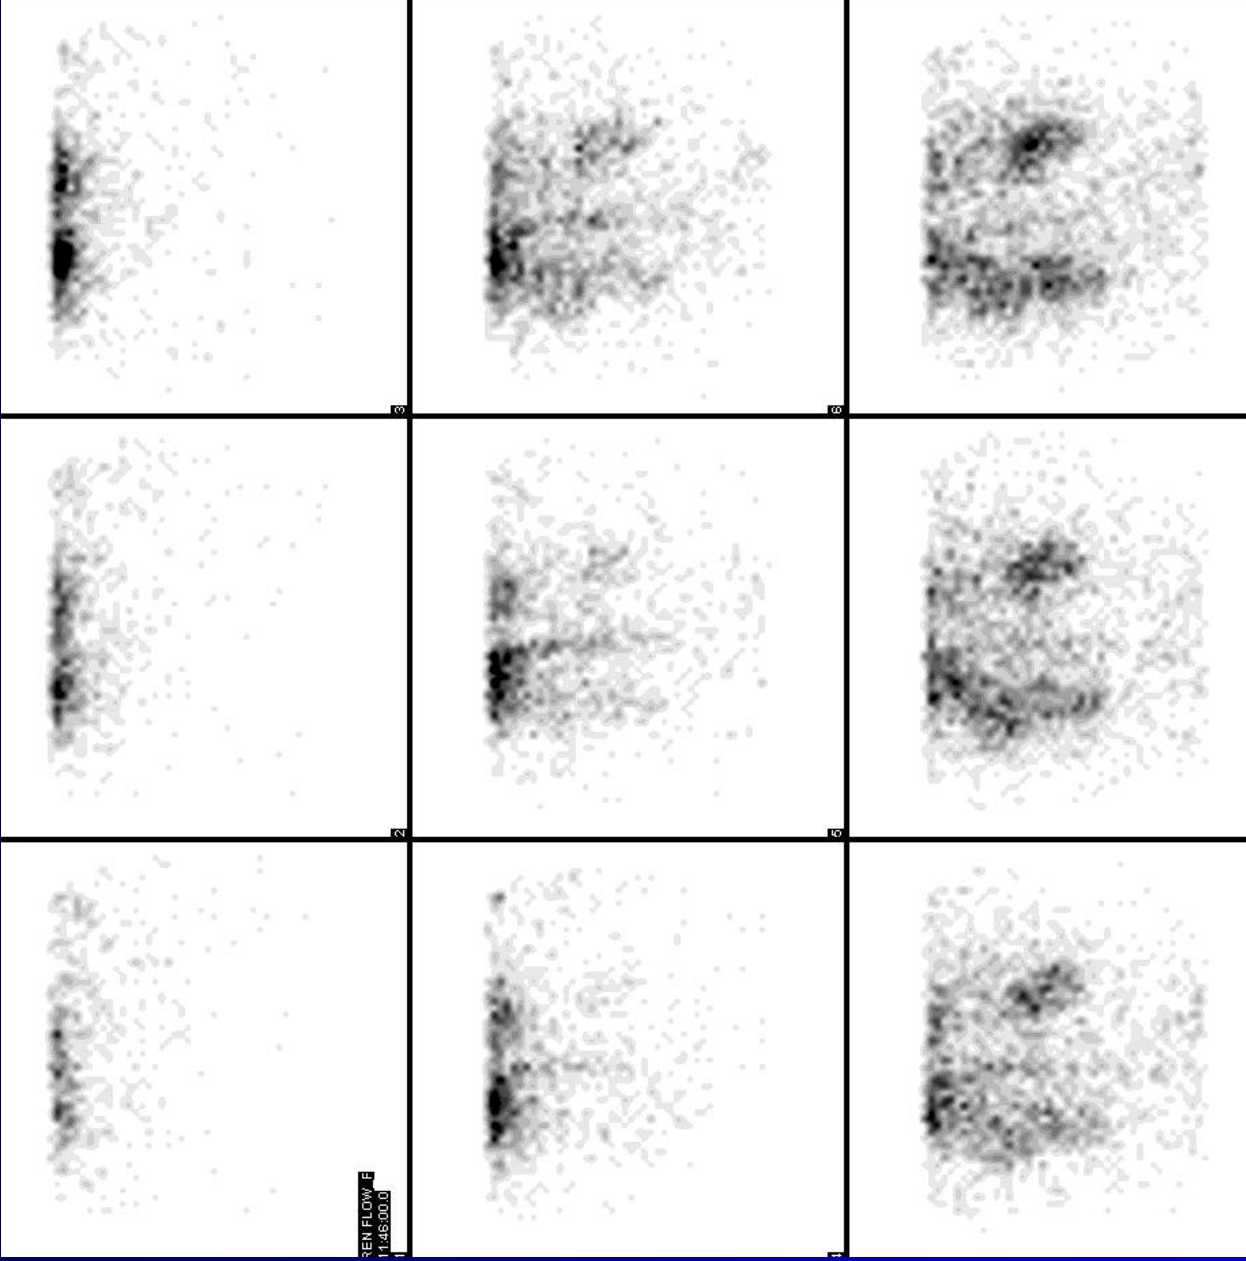
Blood flow images from a renal scan, obtained after the oral administration of 25 mgs of captopril: prompt and symmetric activity is seen in both kidneys.

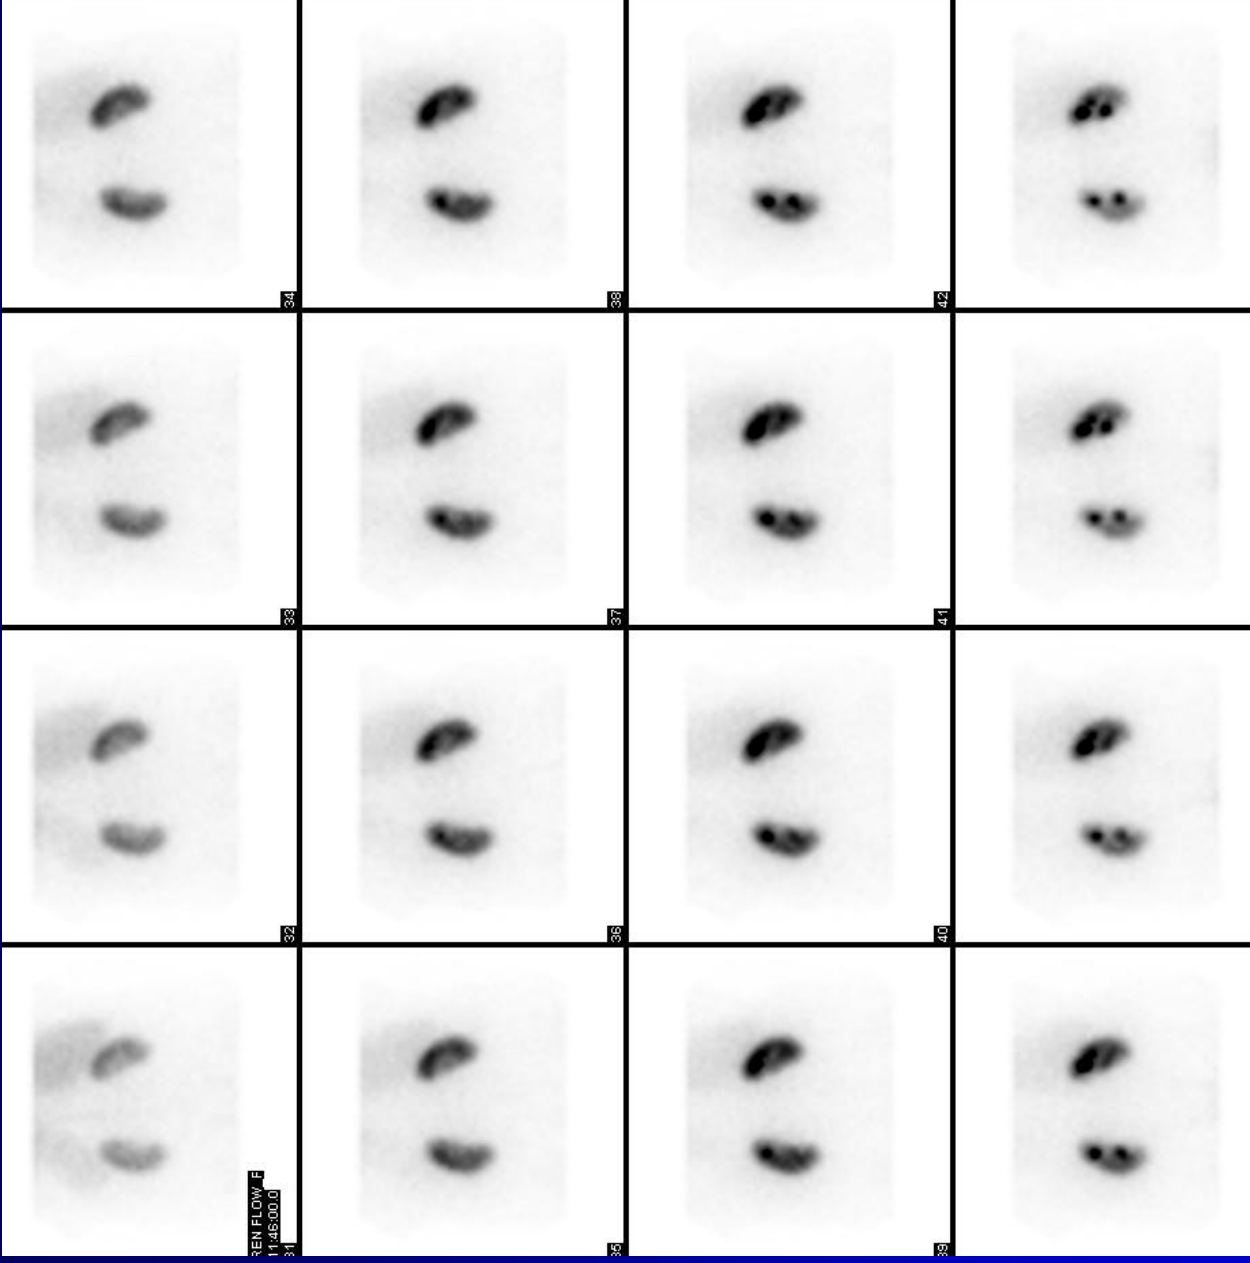
Nephrogram images from the renal scan (with captopril): symmetric uptake of the tracer is seen. Prolonged cortical transit time is seen in both kidneys, suspicious for bilateral renal artery stenosis.
