Blood flow images from a normal renal scan:

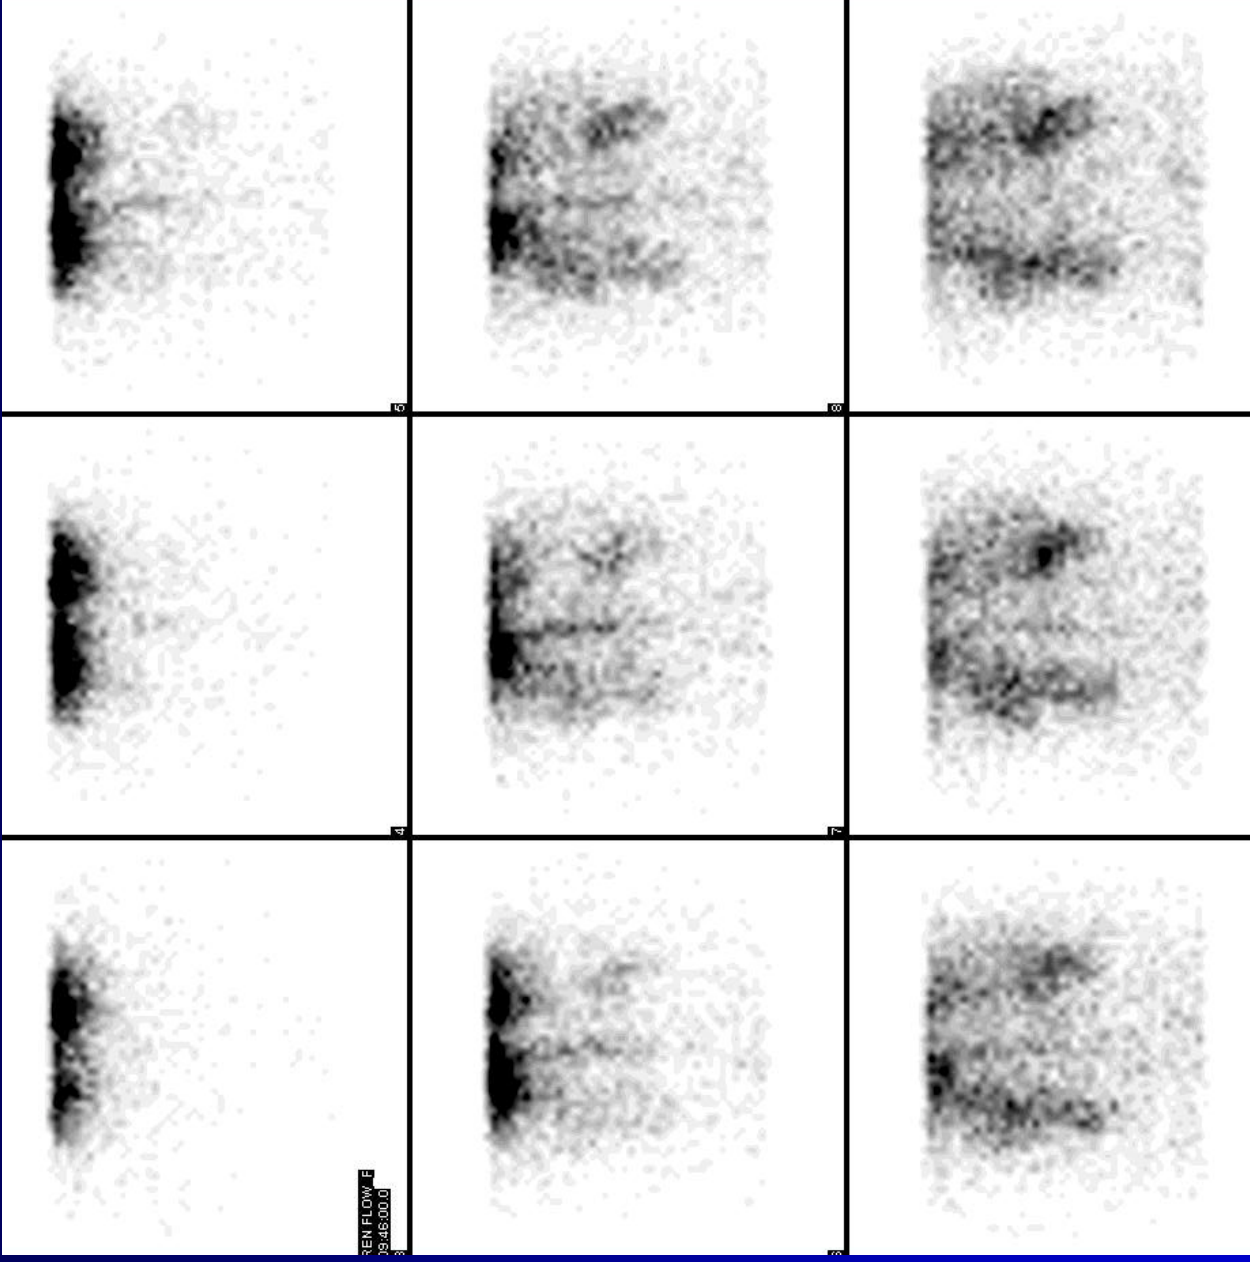
Blood flow images from a renal scan, at baseline (without oral captopril): prompt and symmetric activity is seen in both kidneys.

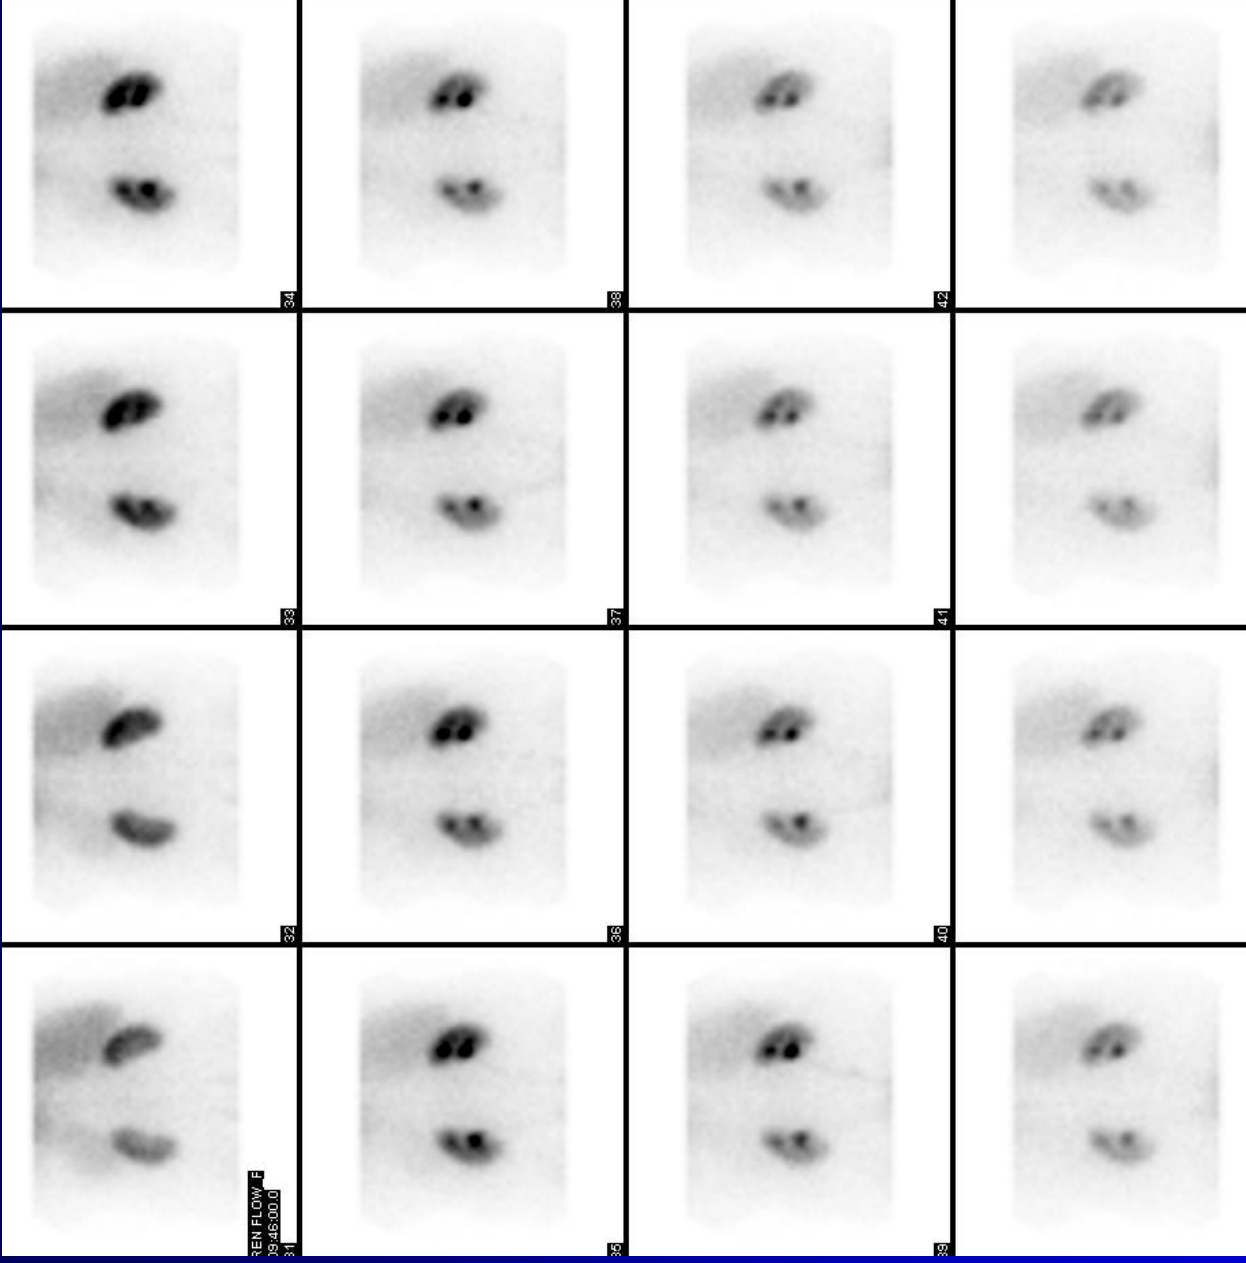
Nephrogram images from the baseline renal scan (without captopril):
symmetric uptake of the tracer is seen. Normal cortical transit time is seen in both kidneys. Findings on the captopril scan are suspicious for bilateral renal artery stenosis. Prolonged retention of the tracer and stasis in the pelvis are also not seen on the baseline scan, as compared to the scan with captopril.

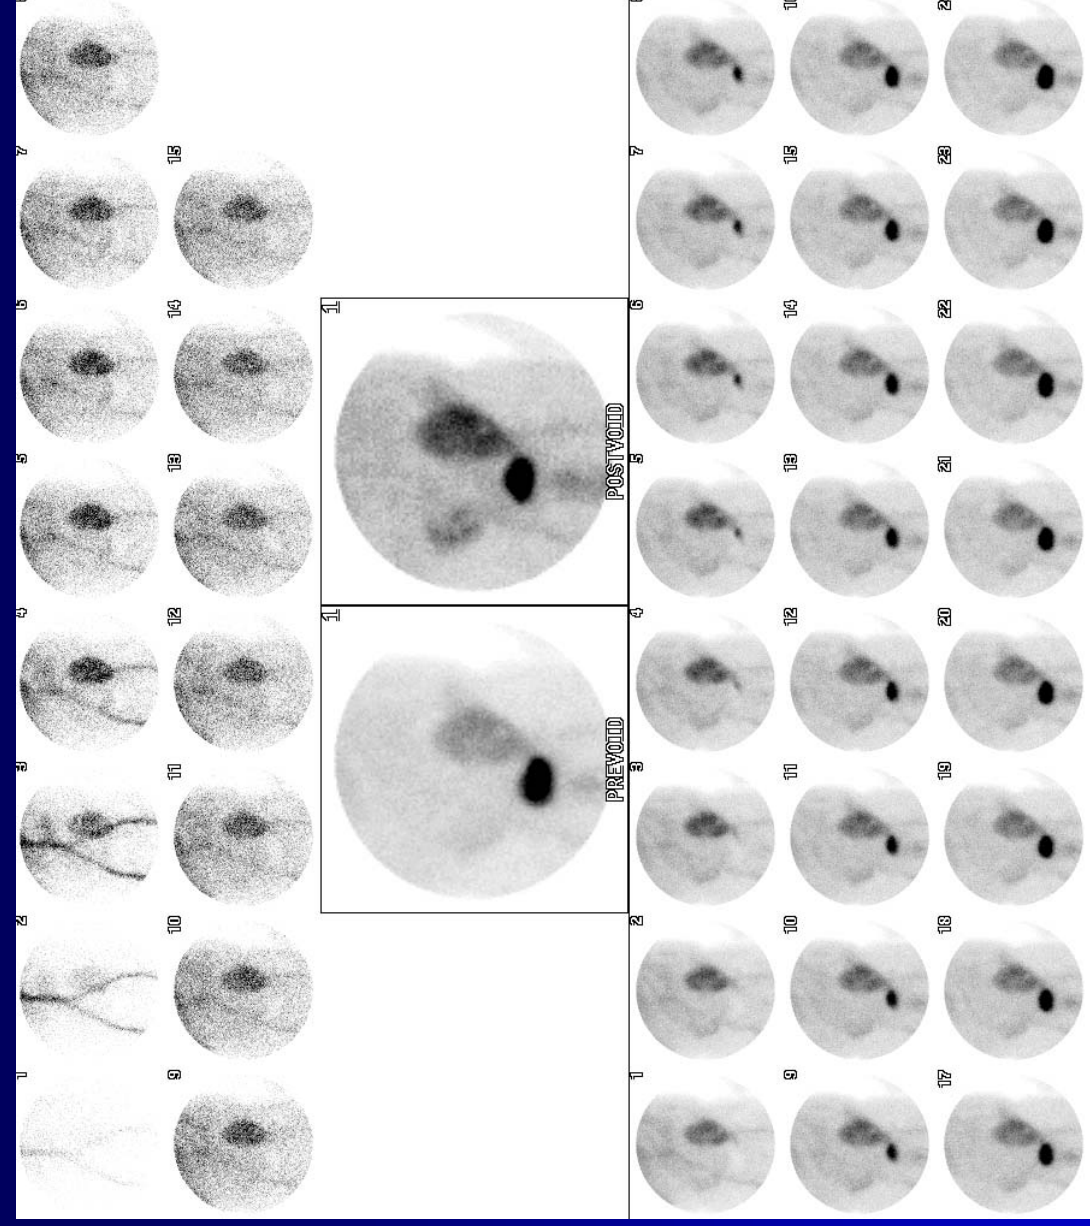
Normal flow and nephrogram images of a left pelvic renal transplant. Dynamic images are acquired in the anterior projection. Good blood flow, and normal uptake and excretion of the tracer is seen in the transplant. Prior failed transplant is seen in the right side of the pelvis.

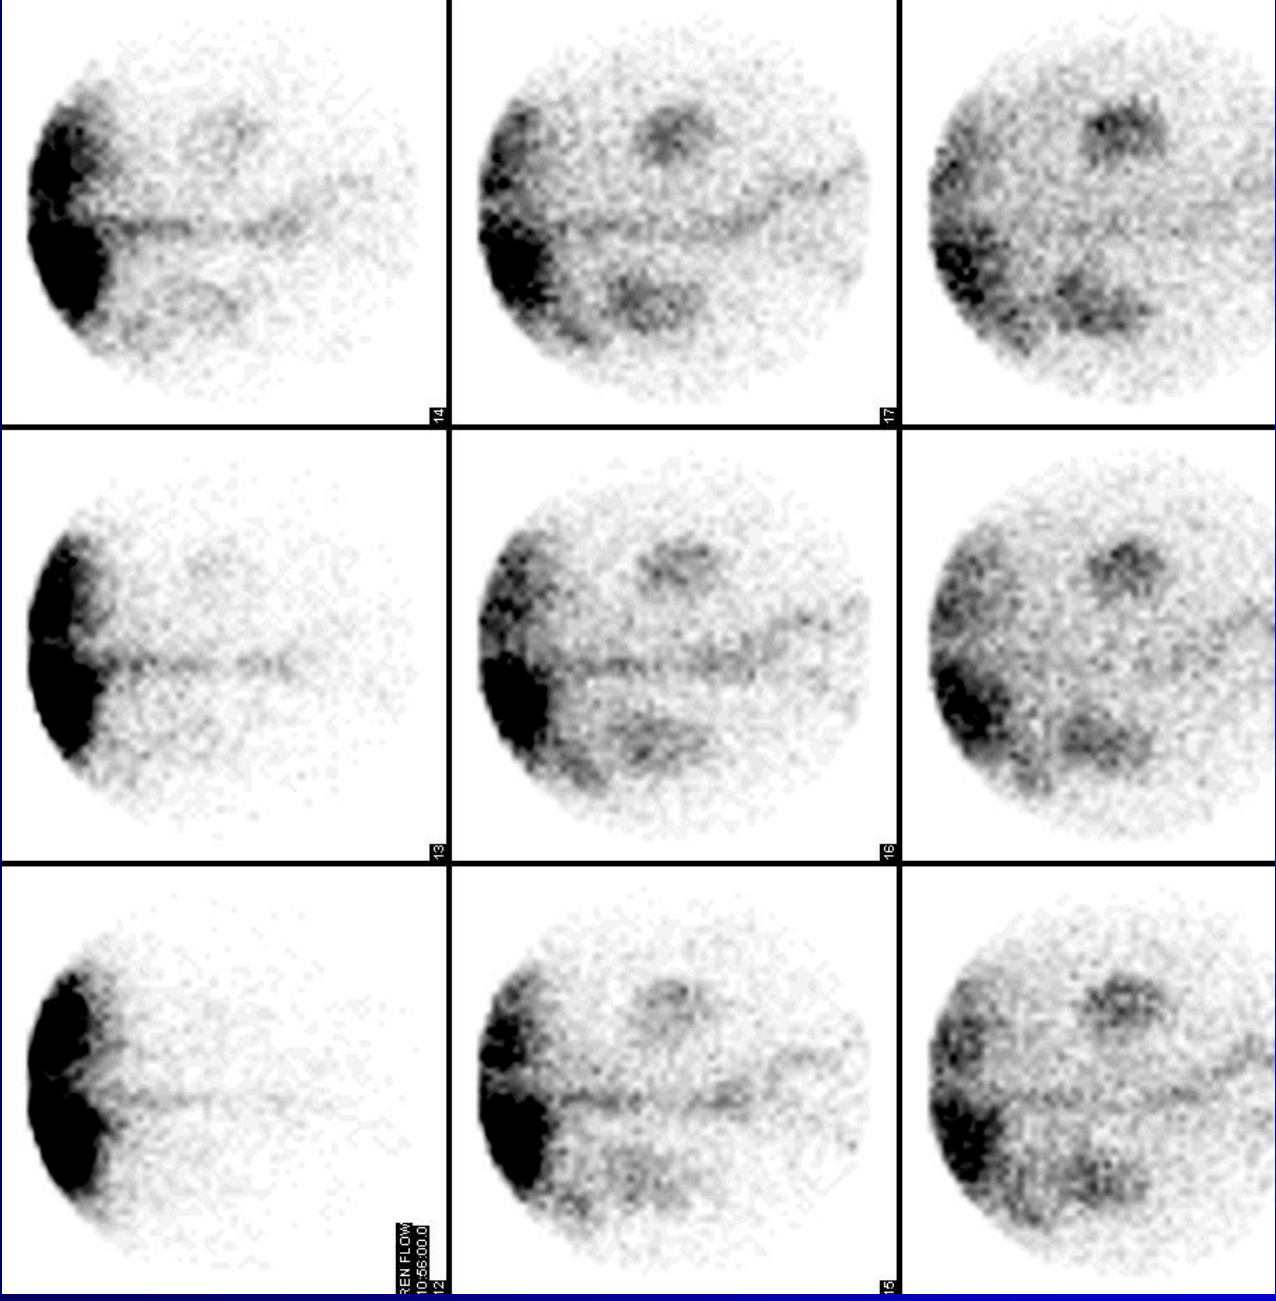
Blood flow images from a renal scan: prompt and symmetric activity is seen in both kidneys.

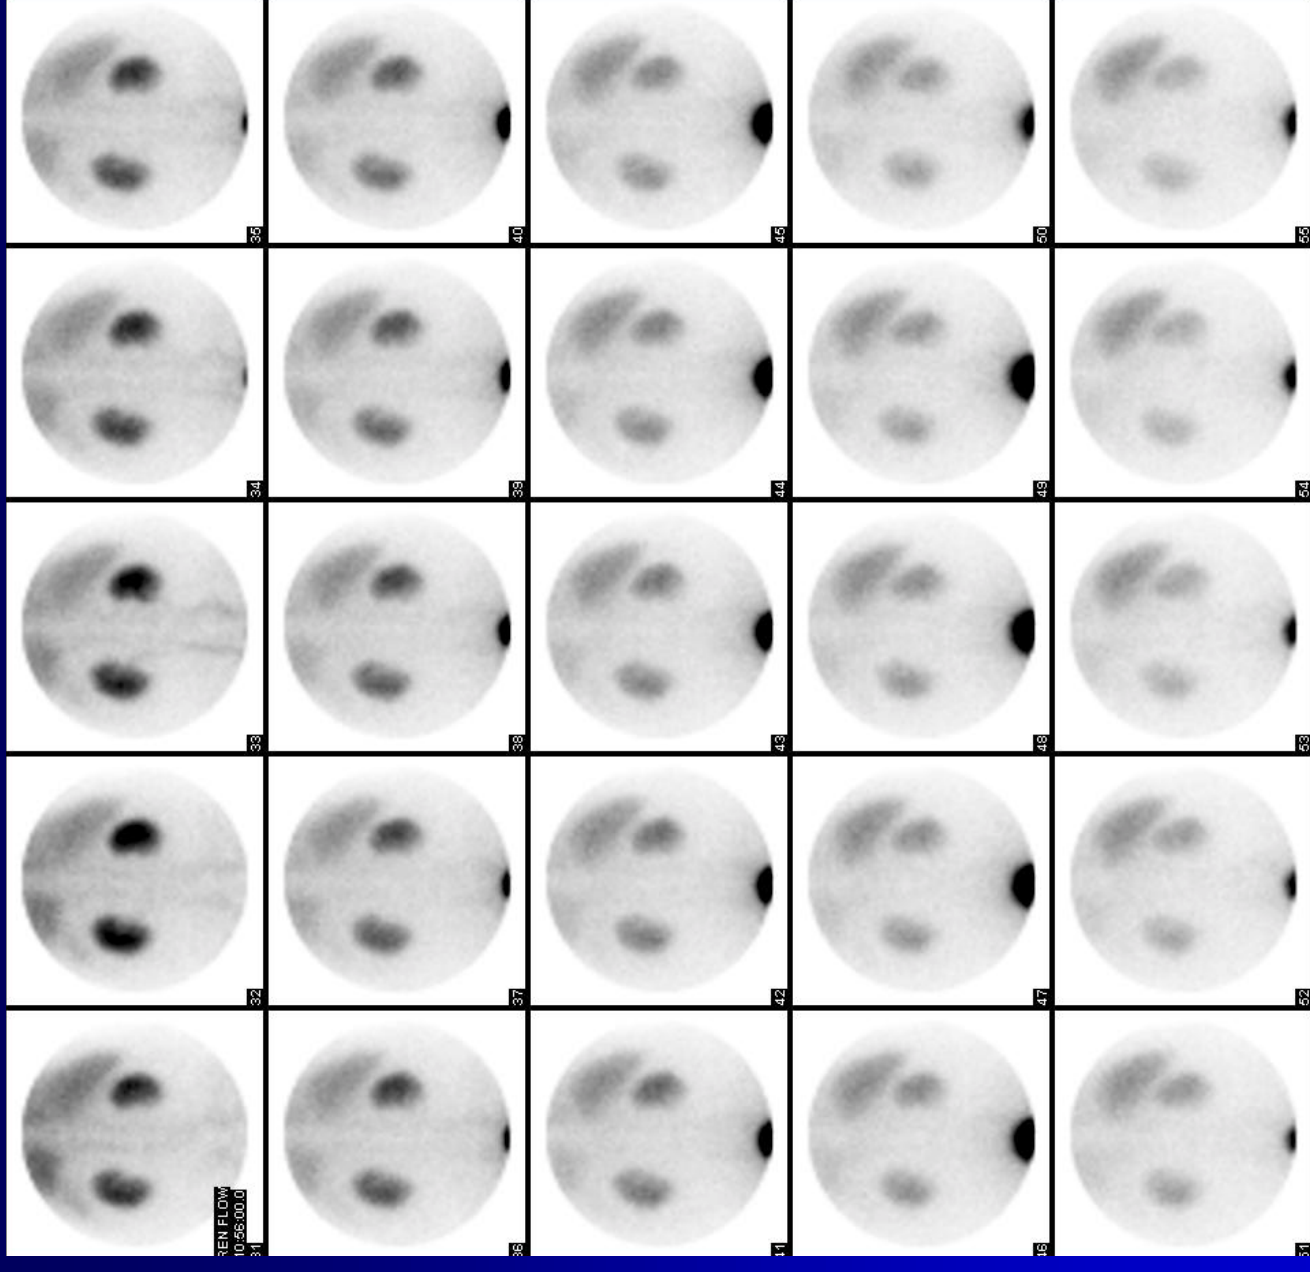
Nephrogram images from the renal scan : normal uptake and cortical transit is seen in both kidneys. Persistence of blood pool activity in the spleen and cortical activity in both kidneys is suspicious for bilateral medical renal disease.
